Texas Commission on Environmental Quality
Investigation Report
MCC RECYCLING LLP
CN603445016

Investigation # 768045

Investigation Type : Compliance Investigation

Location : 200 N RICHEY ST., PASADENA,
TX 77506

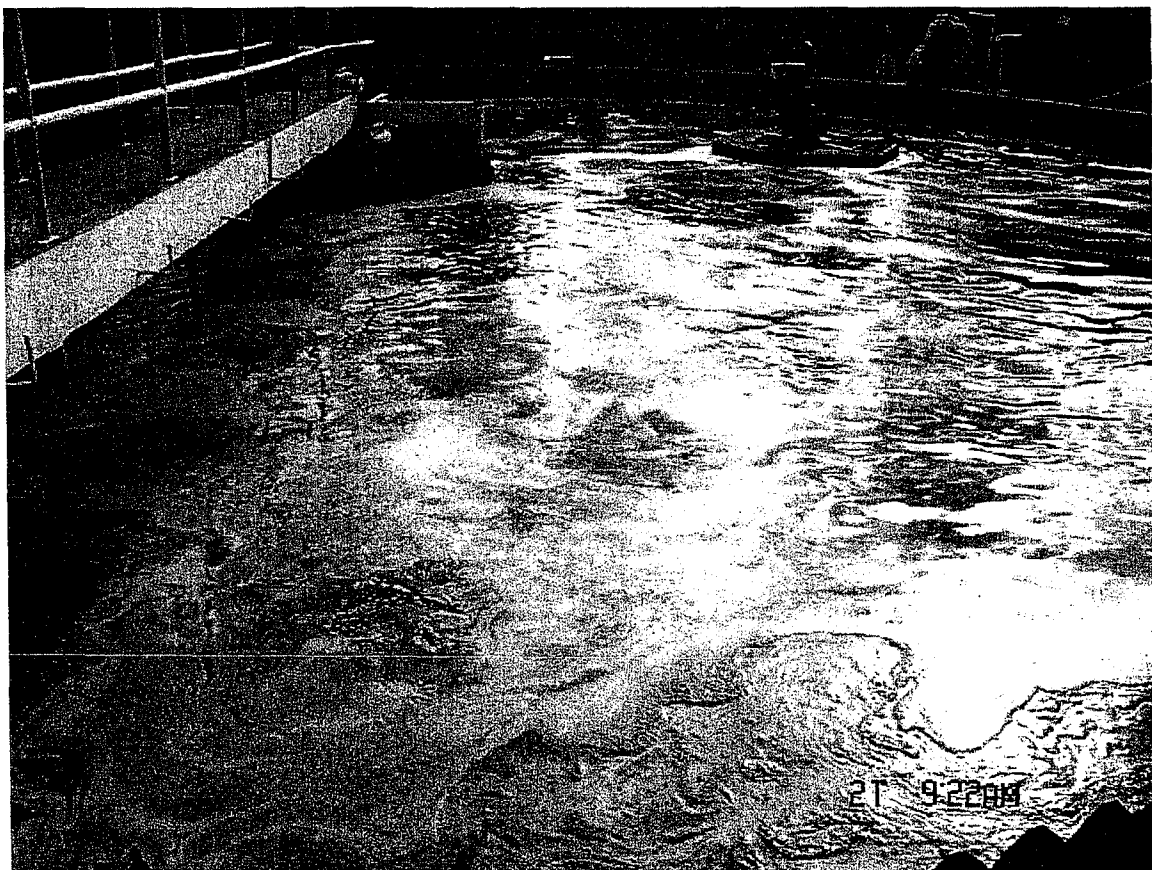
1. This is a picture of the aeration basin at the MCC Recycling facility west plant. The color has improved since the investigation which occurred May 18, 20, and June 3, 2009. The date in the corner of the picture is incorrect. The actual date was August 20, 2009.

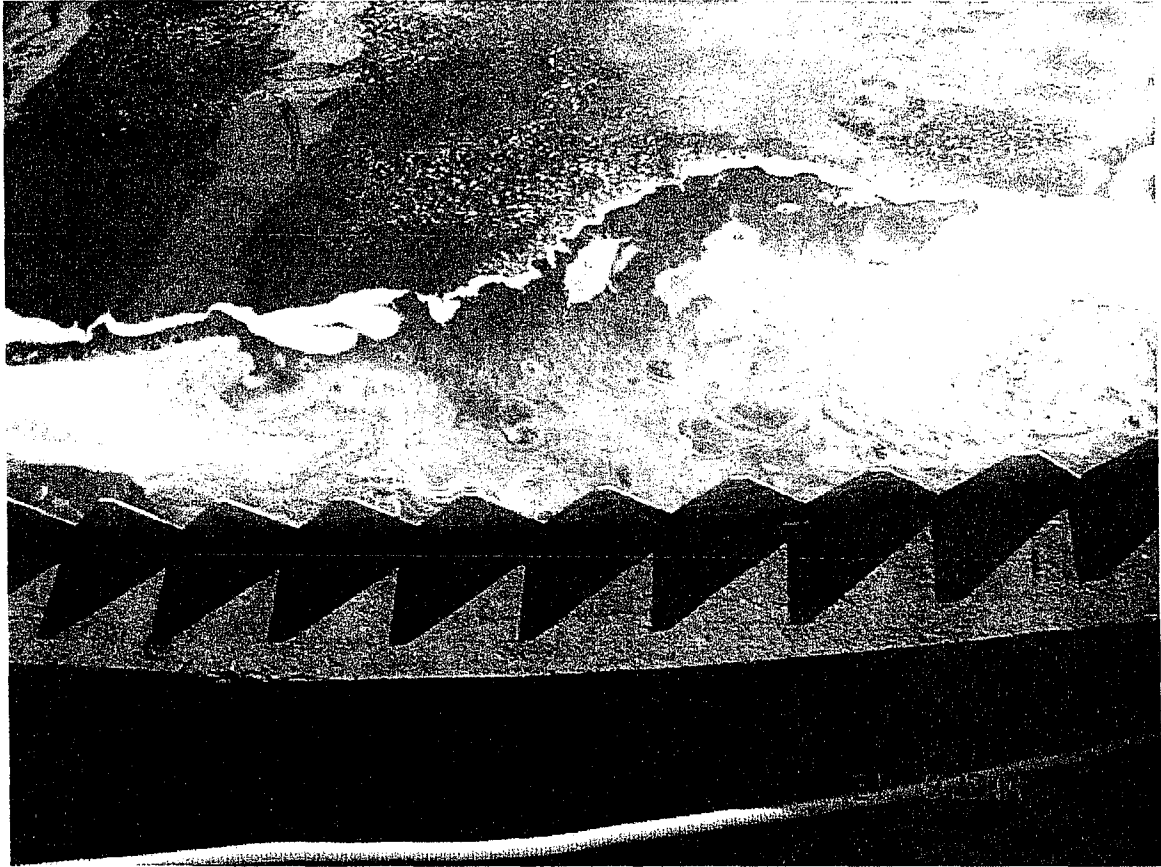
2. This picture is a close up of the aeration basin at the MCC Recycling facility west plant. Note the color of the water is brownish. The picture also documents that the water level was being kept with at least 18 inches of head space and that the outer flume is dry. Also note the condition of the weirs. This provides a comparison of weirs in other vessels which are being used as clarifiers. Note that the date in the corner of the picture is incorrect. This picture was taken on August 20, 2009.

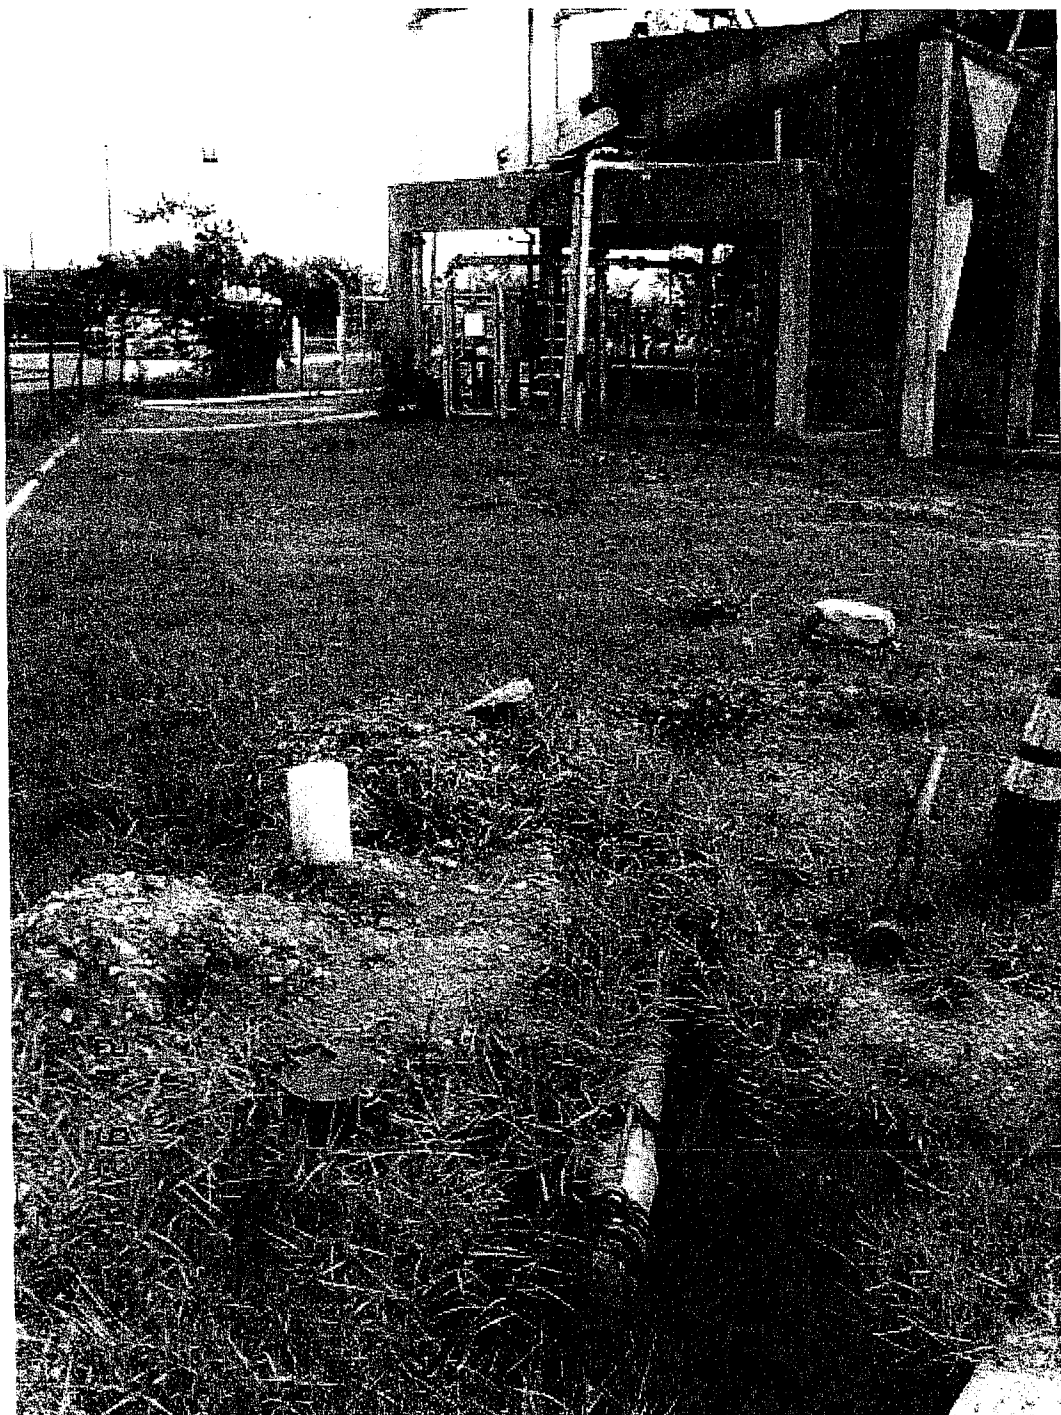
4. This is a picture showing where wastewater pipes enter the MCC Recycling facility west plant. The pipes go up the side of the headworks to the oil water separator then down to the primary clarifier. The pipe zig-zagging in the background are the pipe connecting to the sample point then to the POTW. The date in the corner of this picture is incorrect, the picture was taken August 20, 2009.

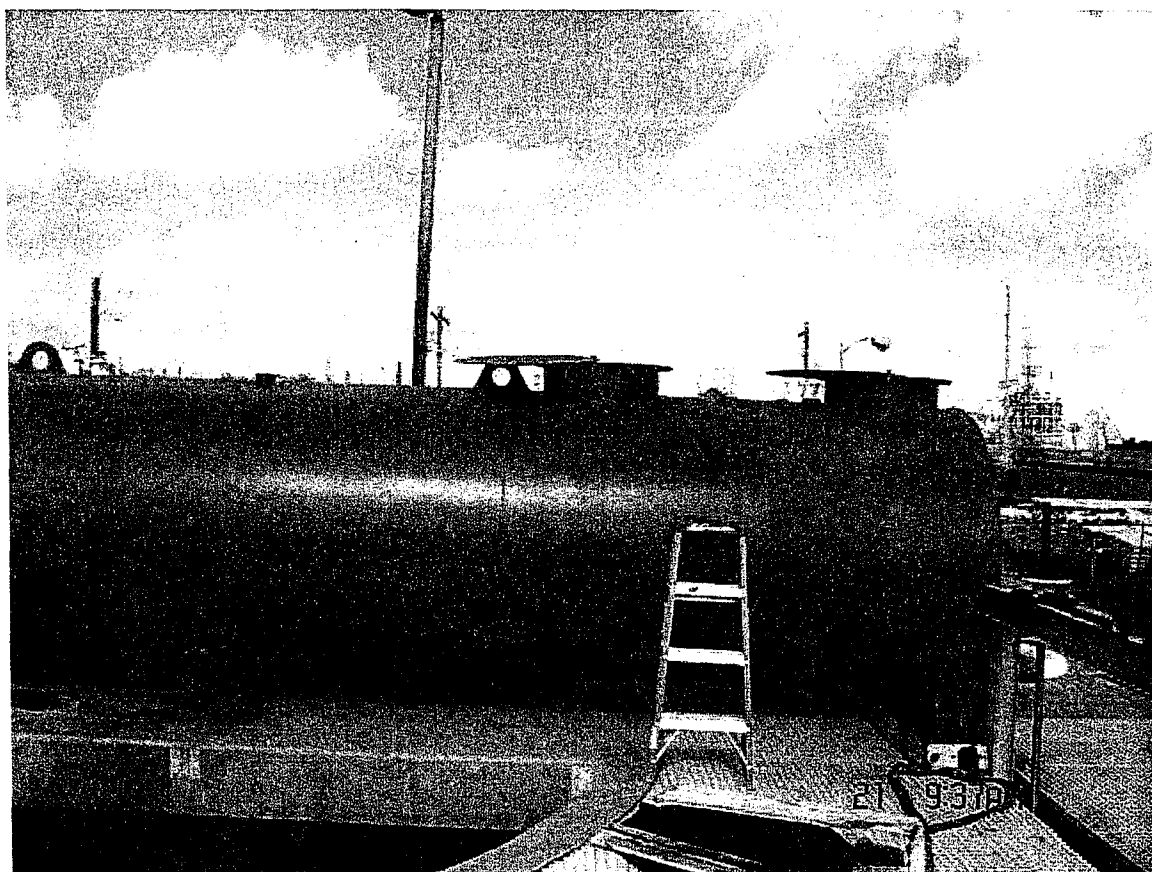
Failure to notify the control authority in advance of any changes to the industrial processes at the MCC Recycling LLP facility. MCC Recycling LLP has added an oil water separator to their wastewater treatment process. Since MCC Recycling is subject to applicable pretreatment standards contained in 40 CFR Part 437- Centralized Waste Treatment Point Source Category, the wastewater treatment process at MCC Recycling is the industrial

5. This is a picture of the new oil water separator located on top of the headworks. The blue device is the oil water separator. Wastewater from US Oil Recovery enters the chamber at the far right of the separator. The cover over the influent was open allowing odors to escape. The cover over the second chamber was also open. The date in the corner of the picture is incorrect. The picture was taken August 20, 2009.

Recommended Corrective Action: MCC Recycling must submit all required reports including reports of changed discharge to the TCEQ and the City of Pasadena.

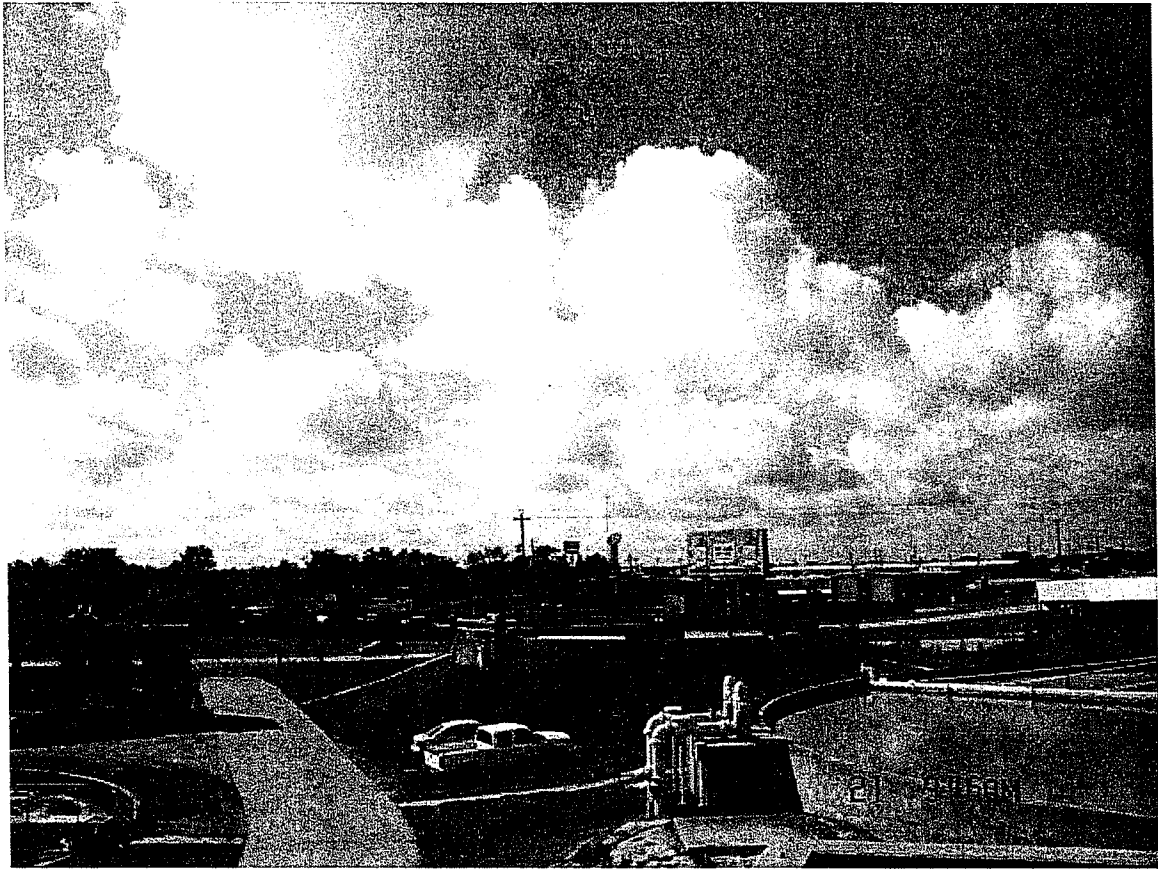
6. This picture was taken from on top of the headworks. This shows the west plant at MCC Recycling. In right hand foreground is the trickling filter. Note that the filter media is covered with water and one of the rotating influent distribution arms is touching the surface of the wastewater. In the background is the primary clarifier. In the lower left corner is the aeration basin. The date on this picture is incorrect. The correct date is August 20, 2009.

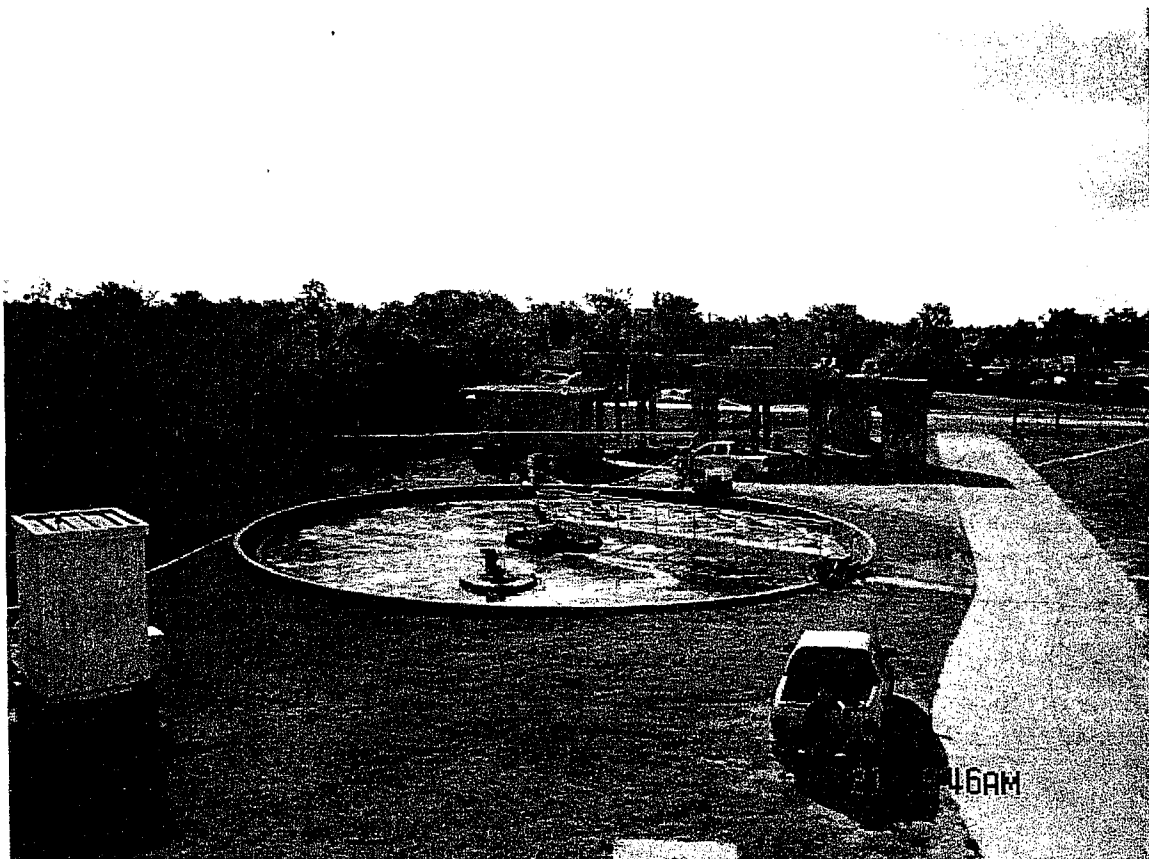
7. This picture was taken from the top of the headworks of the MCC Recycling facility west plant. The picture shows the aeration basin. Note its proximity to the trees on the left of the picture. The trees run along the west bank of Vince Bayou. The date in the corner of the picture is incorrect. The correct date is August 20, 2009.

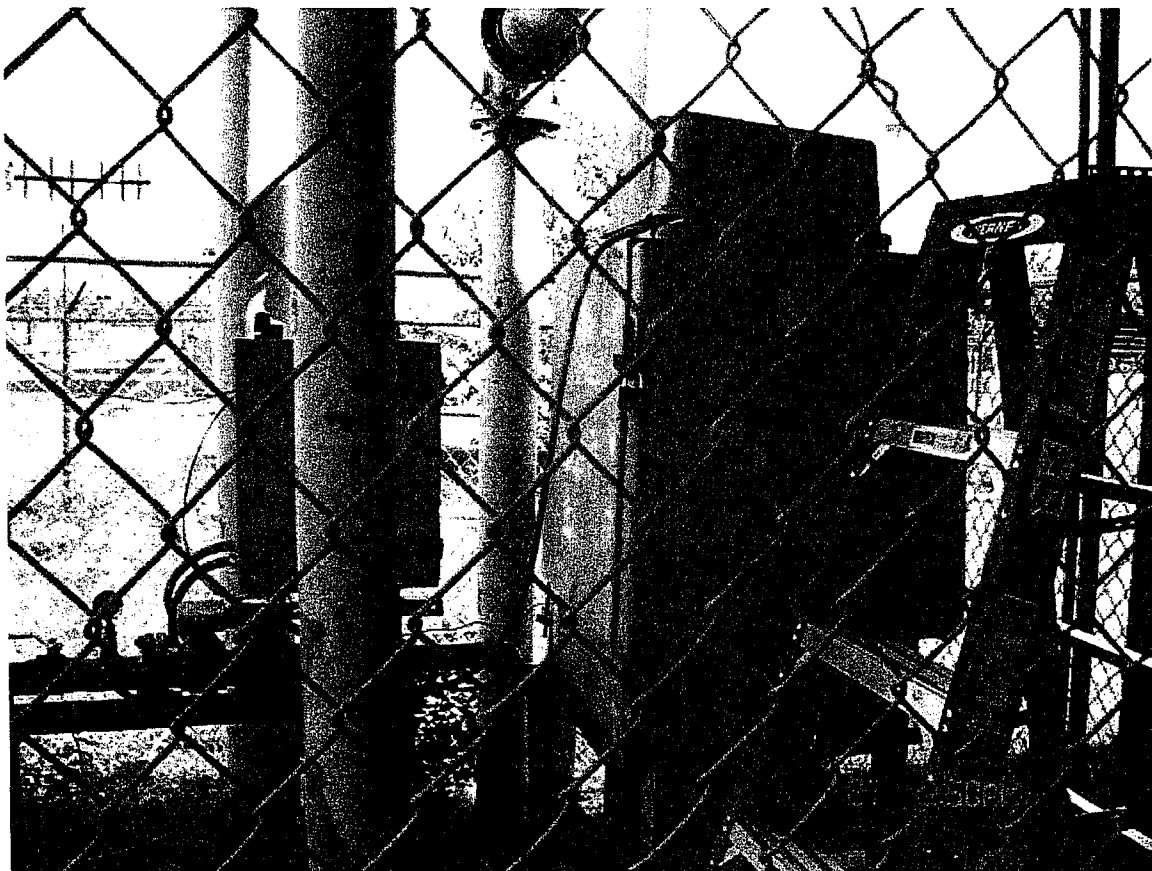
8. This is a picture of the City of Pasadena Automatic Sampler. The site serves as the pretreatment compliance monitoring point. The site is located before wastewater from the MCC Recycling facility is discharged to the City of Pasadena wastewater collection system. The auto-sampler is enclosed within a fence. Only the City of Pasadena has access to the auto-sampler. The date on this picture is incorrect. The correct date is August 20, 2009.

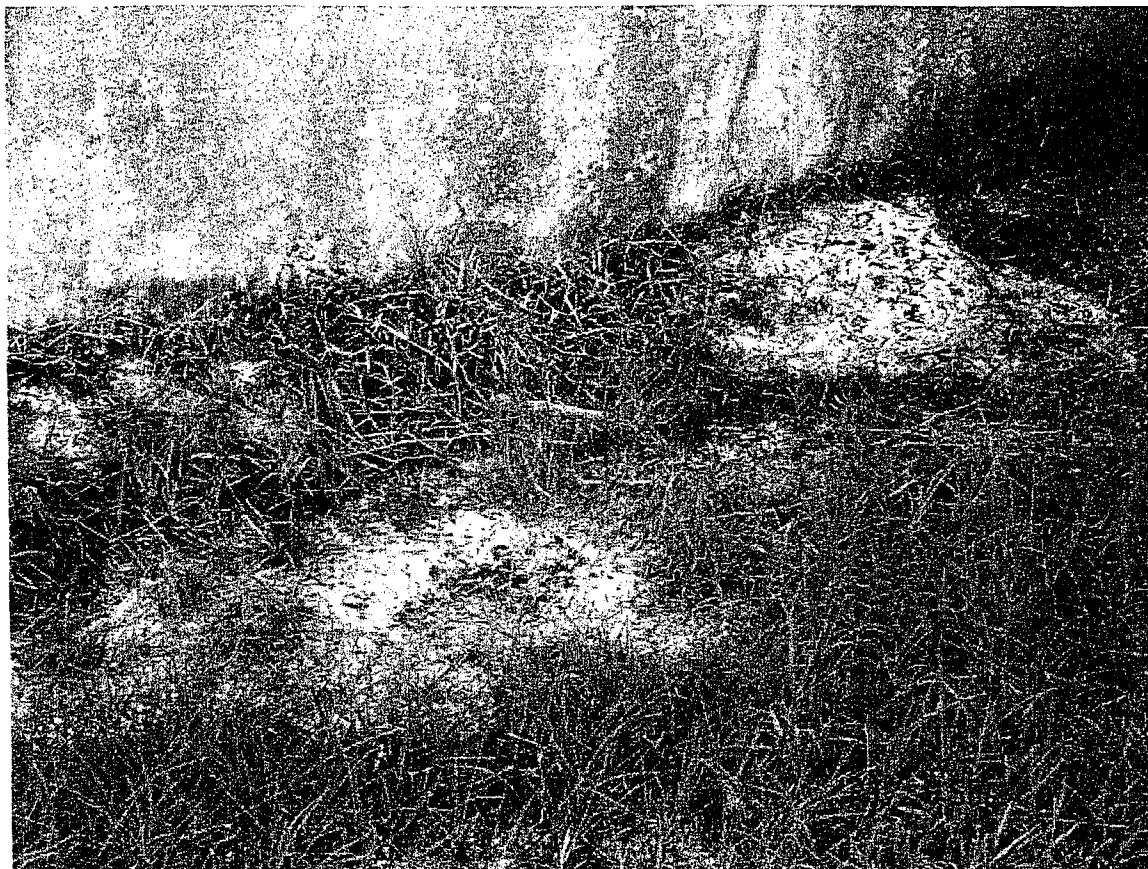
The injunction required that all unauthorized discharges of wastewater cease at the MCC recycling facility. As stated above, there were wastewater leaks to the ground from the old trickling filter. (see attached pictures numbers 9, 11, 13, and 15)

Failure by MCC Recycling LLP to prevent an unpermitted discharge of wastewater. The vessel formerly known as the trickling filter was observed to be leaking wastewater onto the ground at the MCC Recycling LLP facility. One of the leaking sites was in view of the Richey Street entrance to the site. MCC Recycling had erected a blue tarp in front the leak. A second and third leaks were observed in the same vessel. one of the leaks was on the side of the vessel facing Vince Bayou.

9. The picture is of wet soil from leak of the trickling filter at MCC Recycling west plant. The date in the corner is incorrect. The correct date is August 20, 2009.

Recommended Corrective Action: MCC Recycling LLP must prevent all unpermitted discharges of wastewater to the environment.

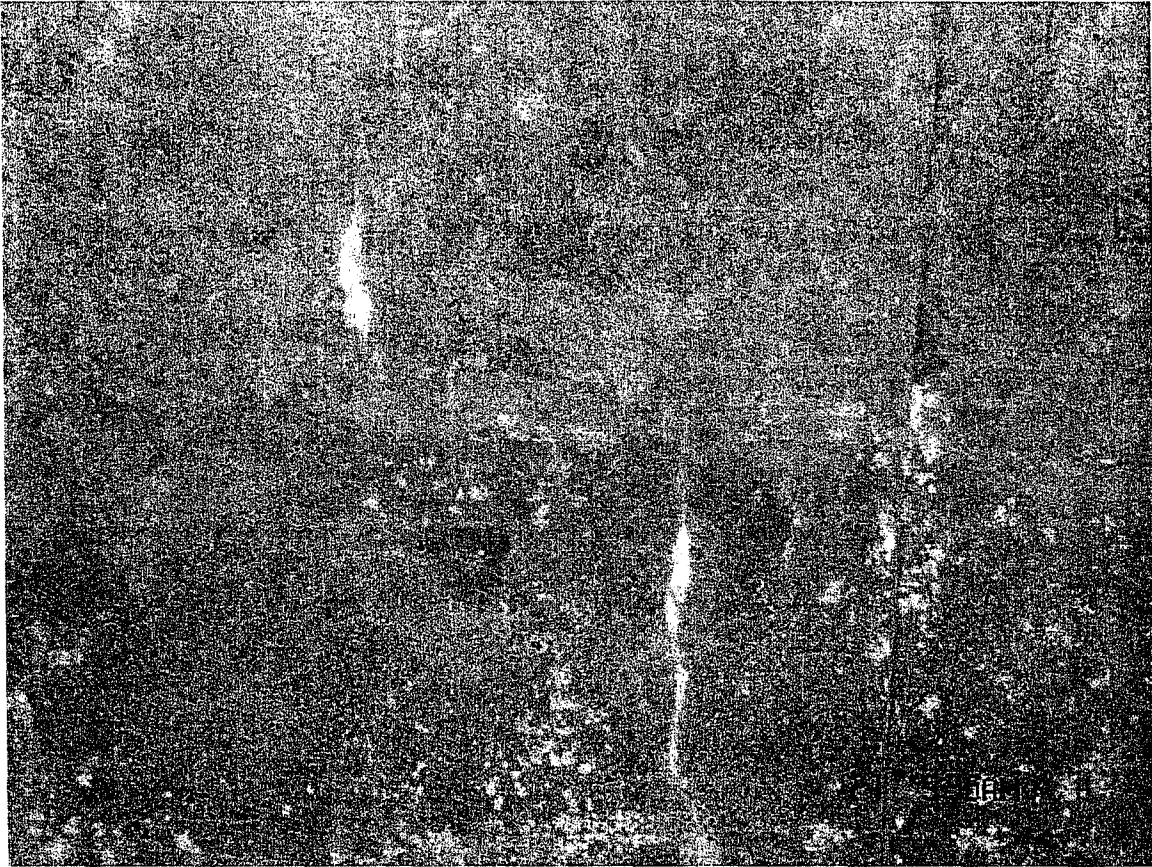
10. This is a picture of repaired cracks in the outer wall of the old trickling filter at the MCC recycling facility west plant. The date in the corner of the picture is incorrect. The picture was taken on August 20, 2009.

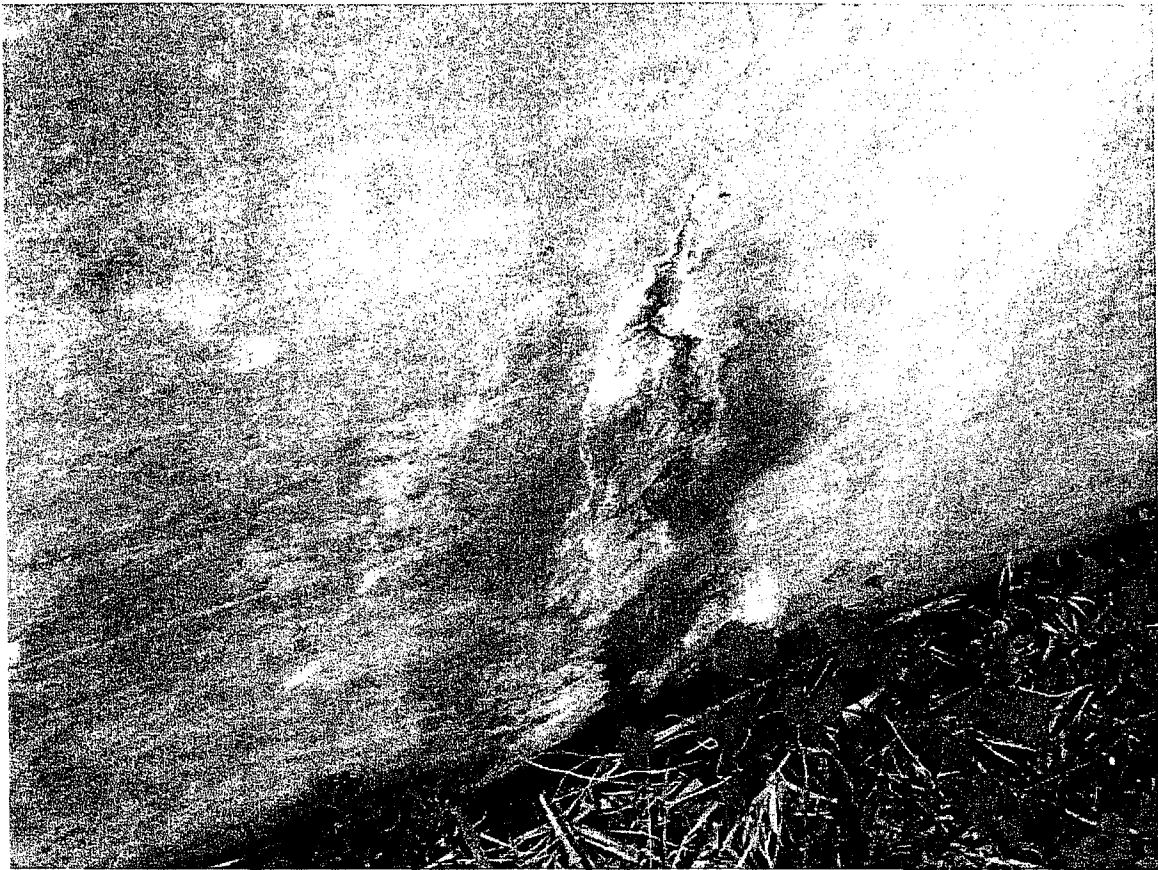
11. This is a picture of an active leak in the wall of the trickling filter. The date in the corner of the picture is incorrect. The correct date was August 20, 2009.

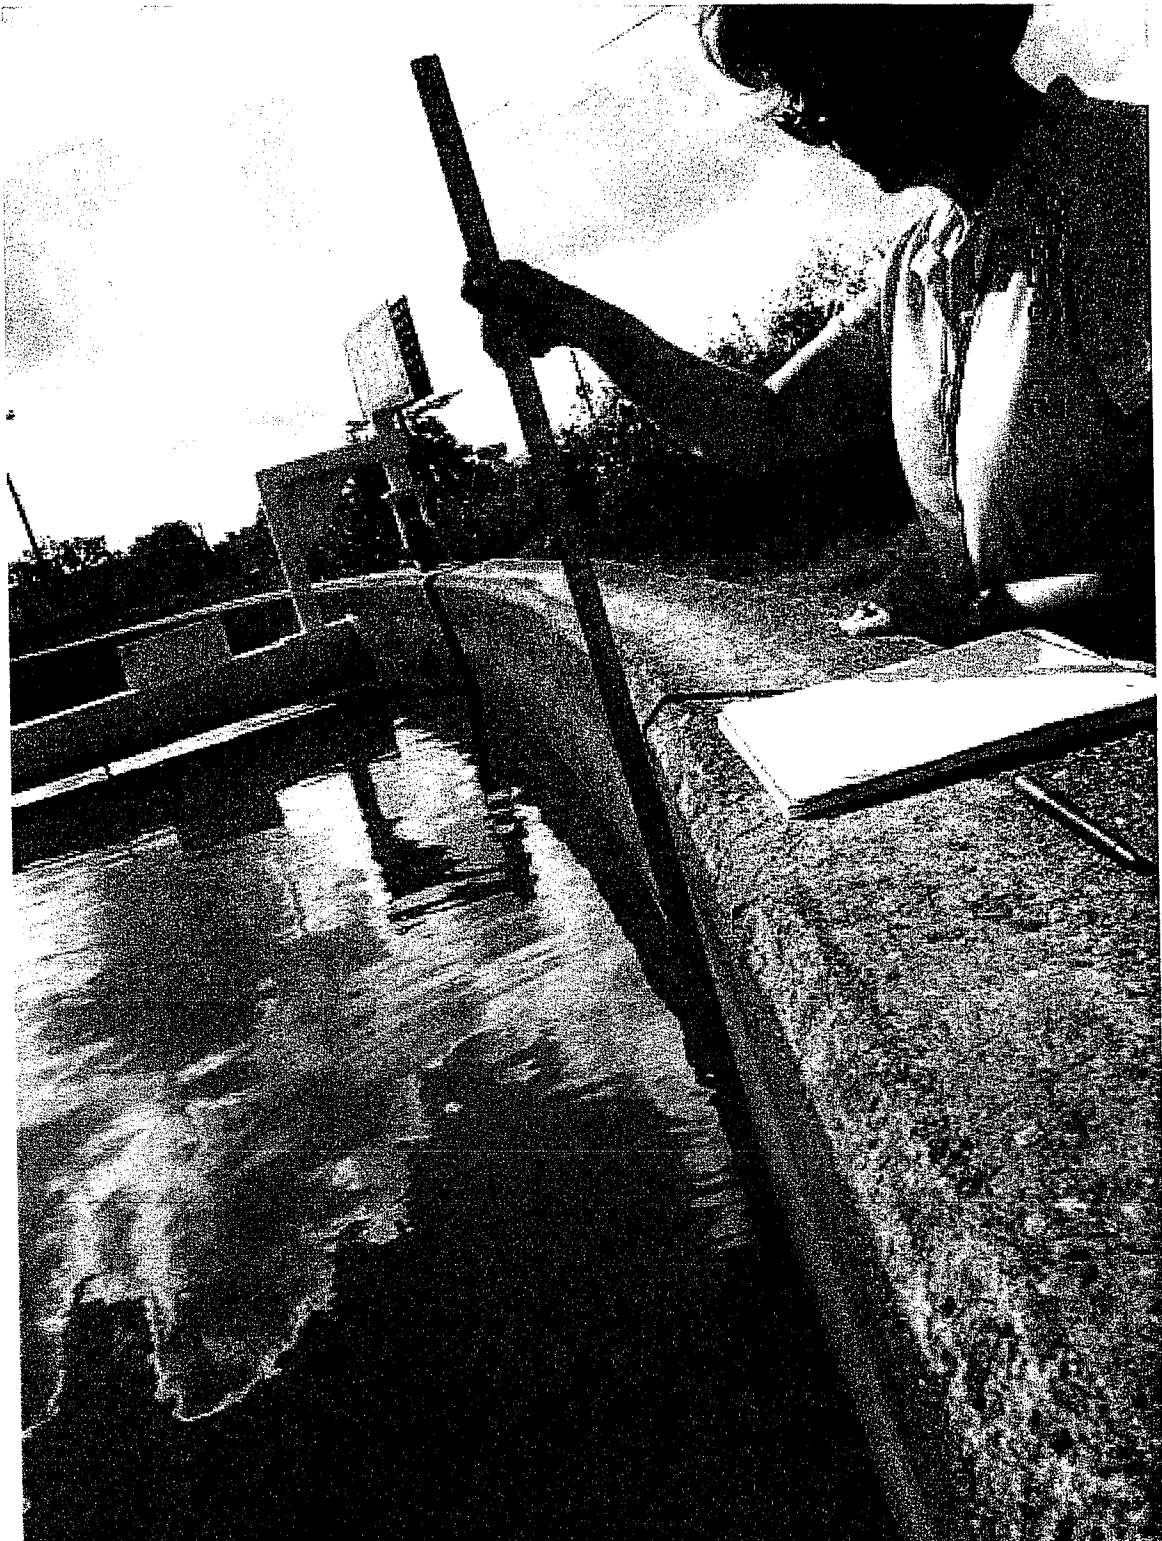
The TI required that a minimum of 18 inches of freeboard to be maintained on all open tanks at the MCC Recycling facility unless the design of the structure in use is being used as intended (for example: an old clarifier is being used as a clarifier or the old trickling filter is being used as a trickling filter). During this investigation, what had been the trickling filter had only 14 inches of freeboard. The old trickling filter did not appear as being used as a trickling filter. The water level was

high enough to touch the bottom of one of the rotating influent distributor arms. (see attached picture number 12)

12. This is a picture of the trickling filter freeboard being measured at the MCC Recycling facility. The measurement indicates 14 inches of freeboard. The date in the corner of this picture is incorrect. The actual date was August 20, 2009.

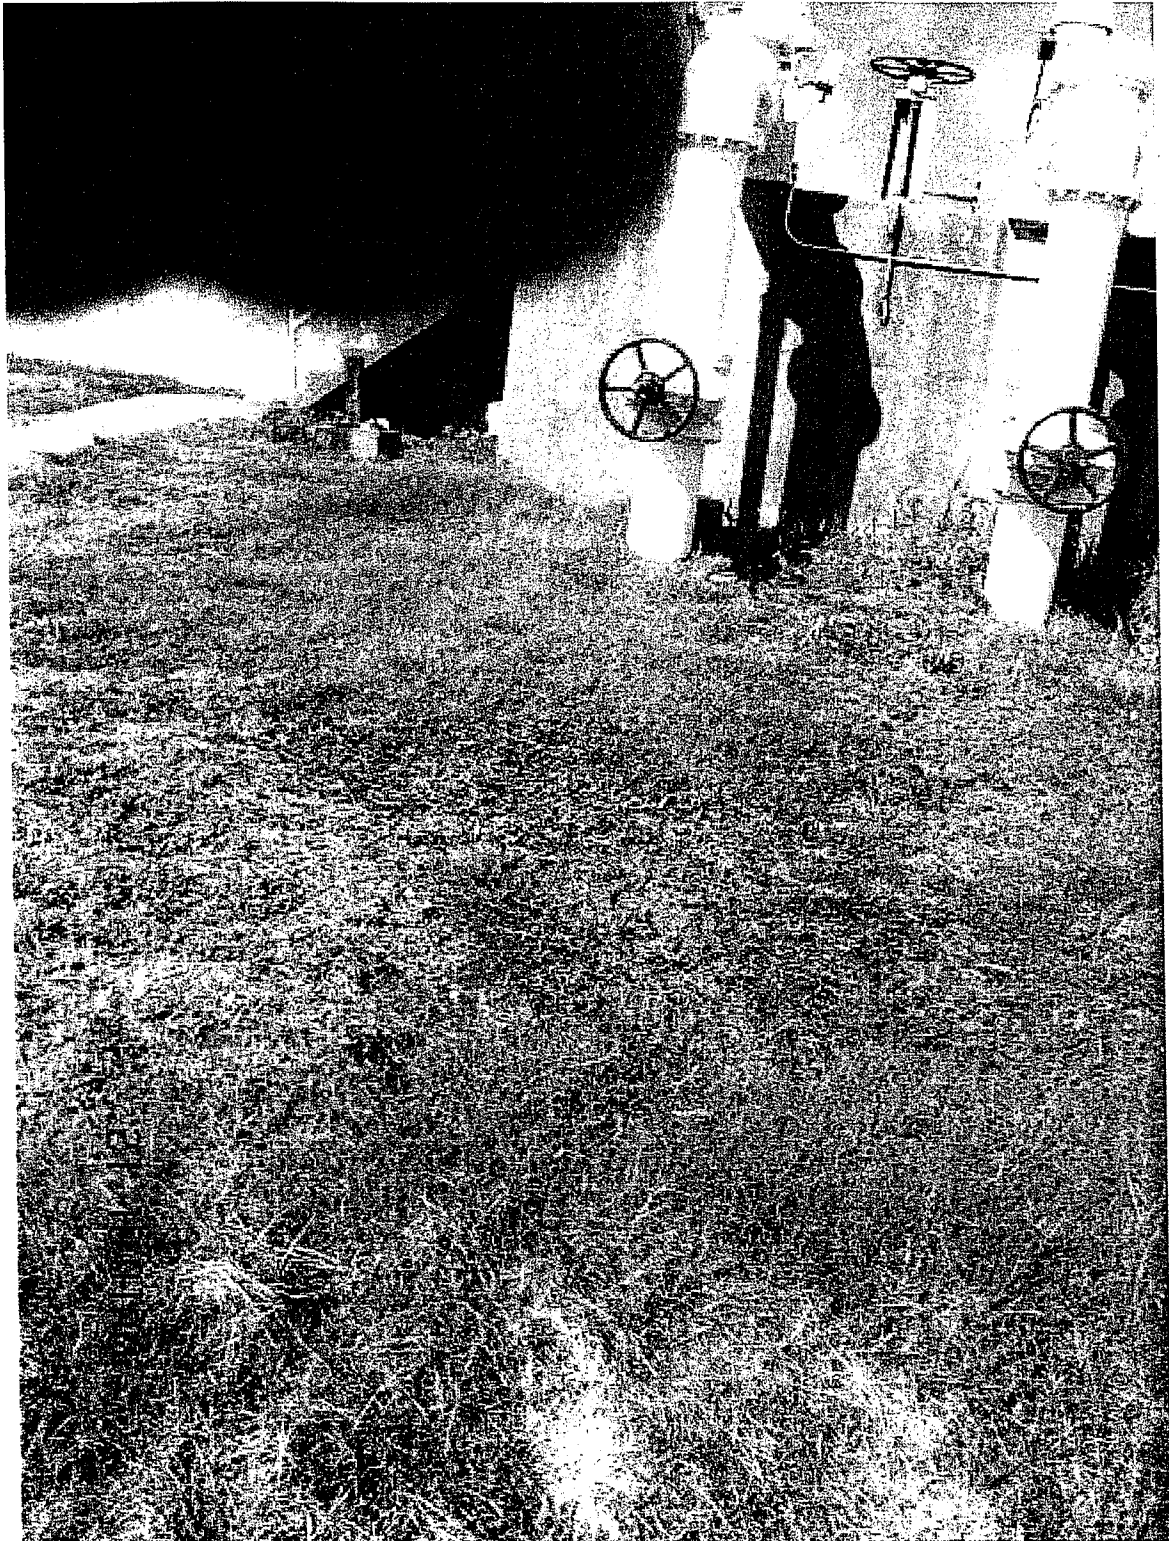
13. This is a picture of damp soil down slope of leak from the trickling filter at the MCC Recycling facility west plant. The date in the corner of this picture is incorrect. The correct date is August 20, 2009.

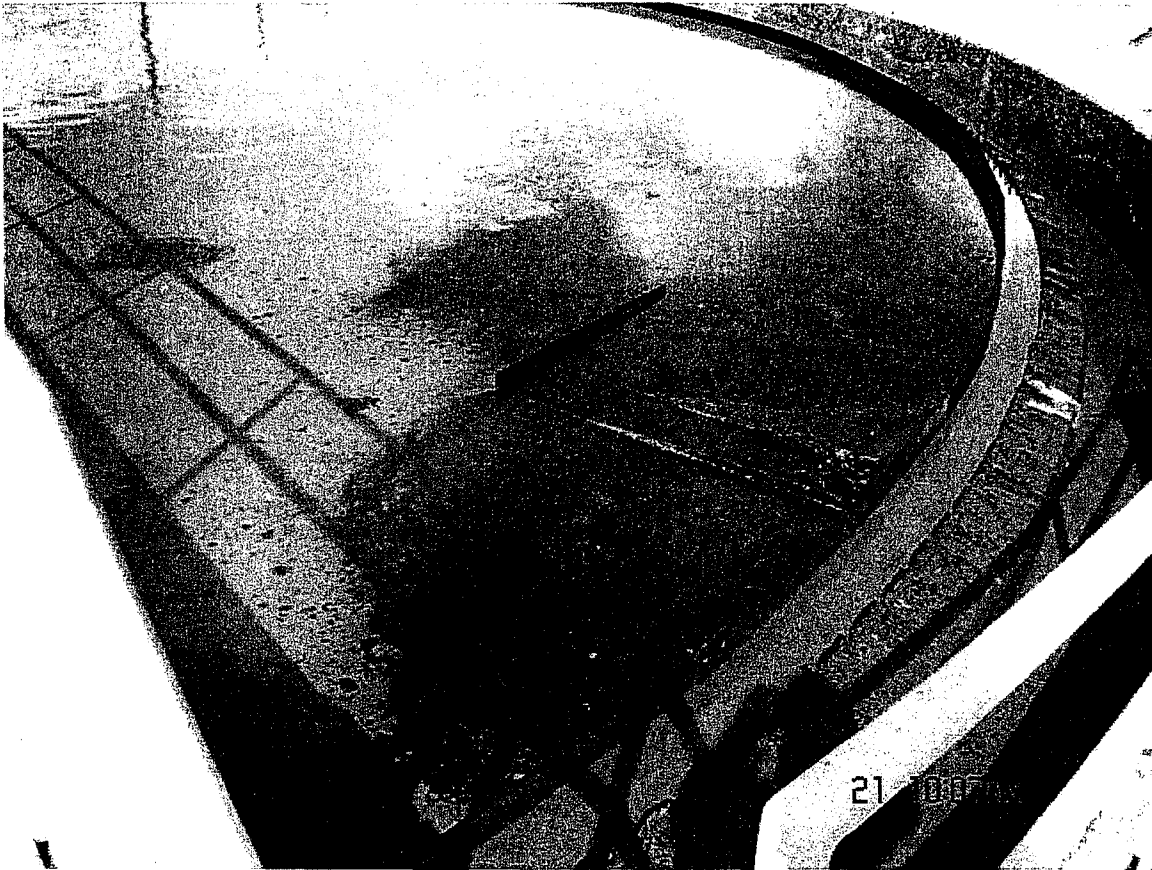
14. This picture shows oil collecting on the surface of the primary clarifier at the MCC Recycling west plant. Also note the condition of the weir. The teeth of the weir are gone. However, this clarifier is baffled which keeps the floatable solids and oils trapped. The water is discharged to the aeration basin. The date in the corner of the picture is incorrect. The correct date was August 20, 2009.

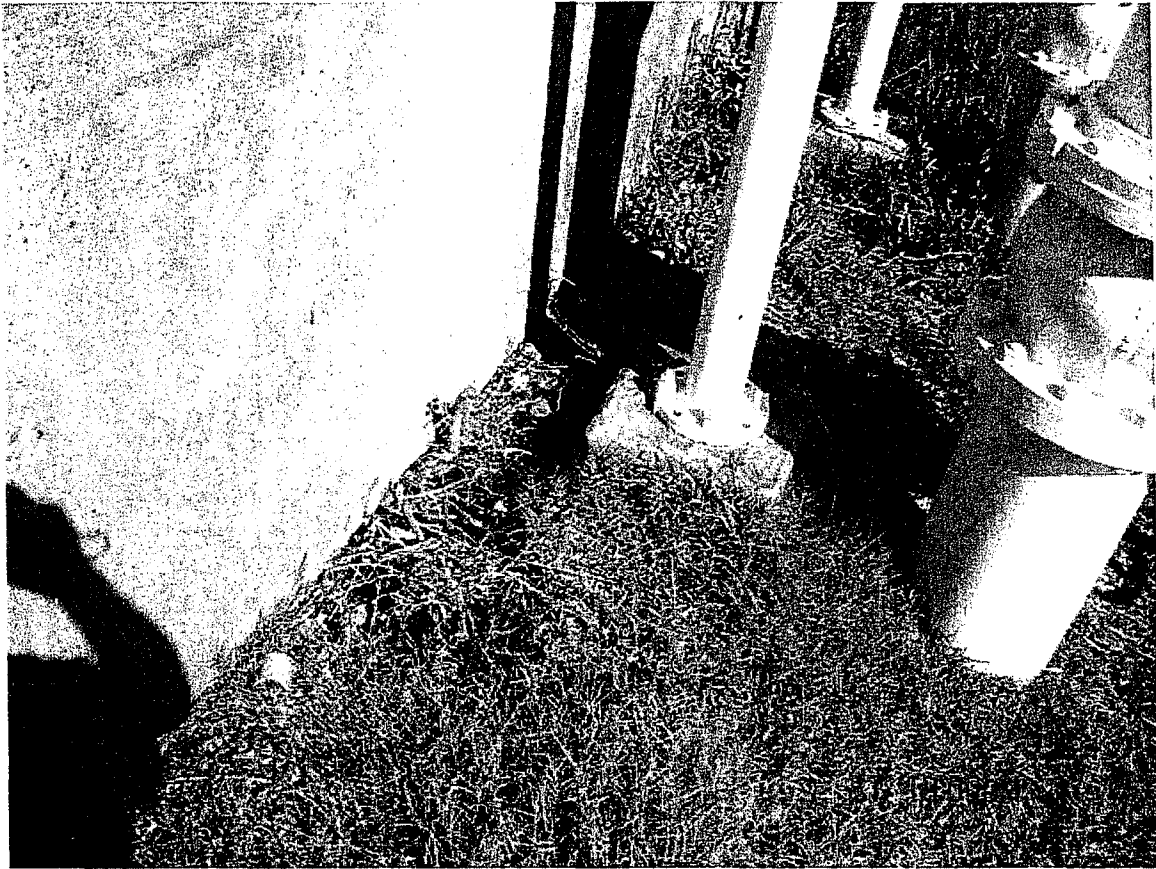
15. This is a picture another active leak at the trickling filter. The leak is at the crack just above the damp soil. The date in the corner of this picture is incorrect. The correct date is August 20, 2009.

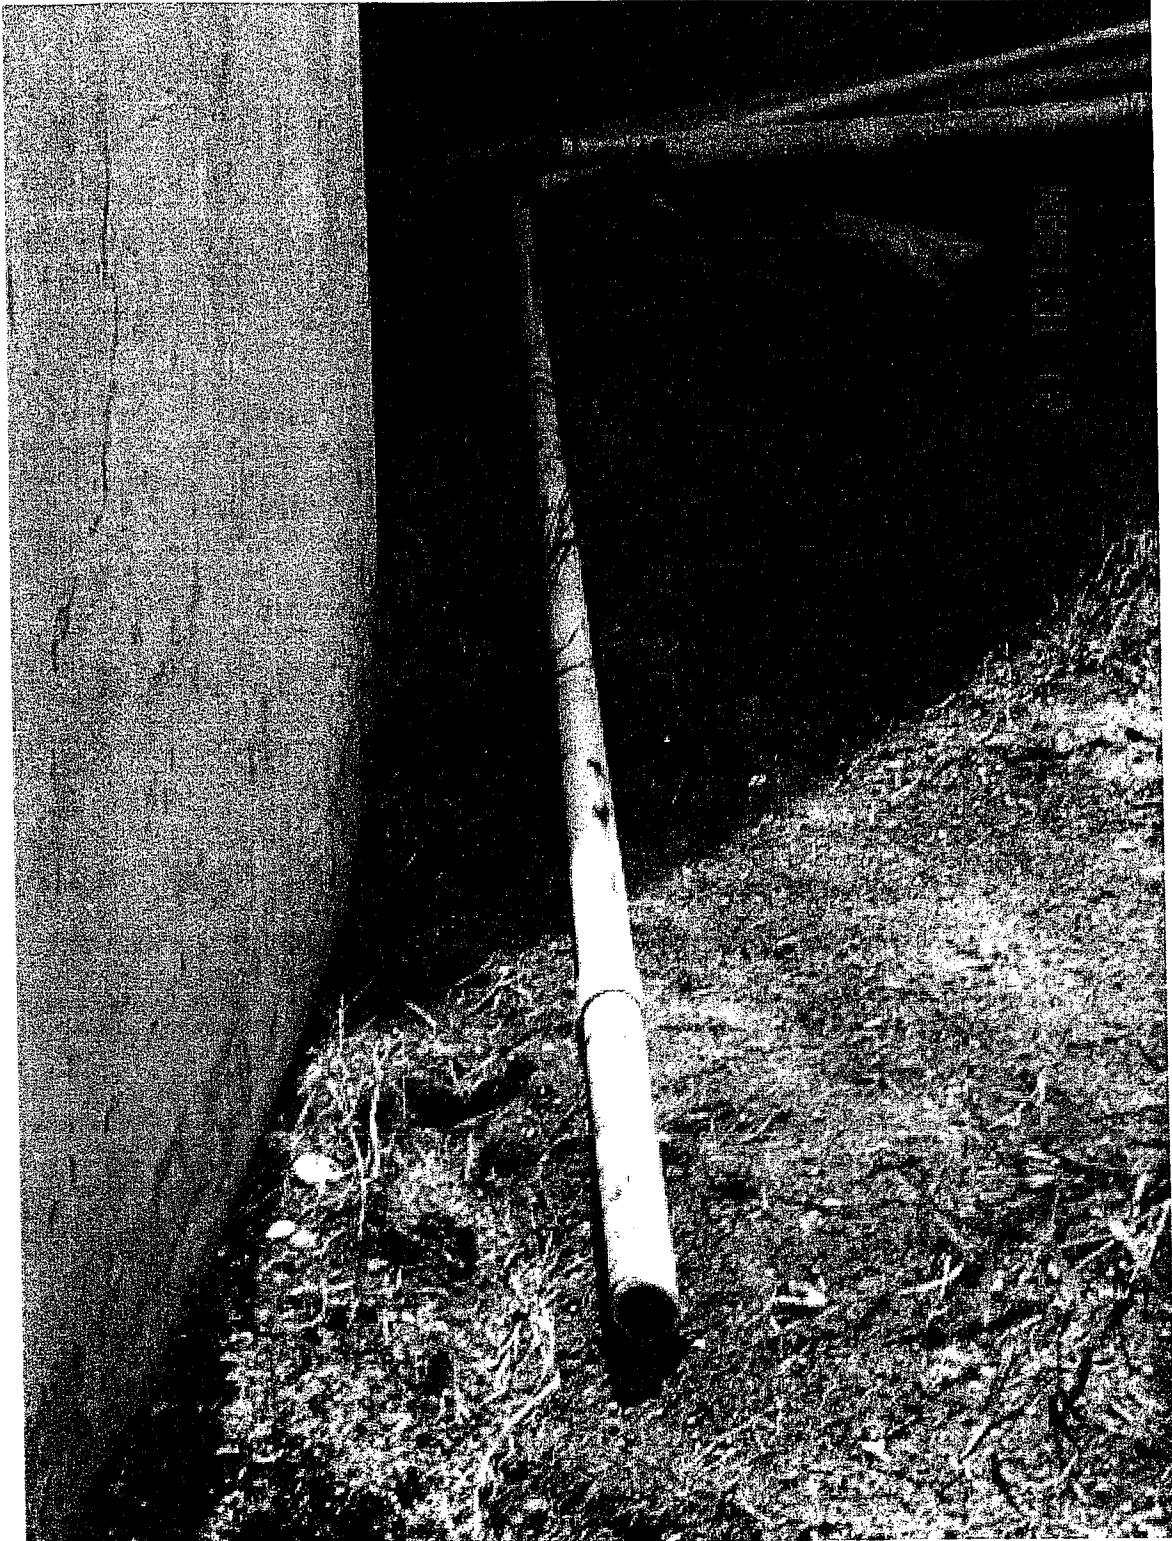
The pump room next to the old digester was investigated. New piping had been installed which appeared to better interconnect the east and west plants. There is more piping being installed. It was not clear where the new pipe was going. At least one segment was still not connected. The mystery pipe found on May 18, 2009, had mostly been removed. The section located under the drive next to the chlorine contact chamber was still there. (see pictures numbers 16, 17, 21, and 26)

16. The picture is of a new pipe next to old digester near pump room. The date in the corner of the picture is incorrect. The correct date was August 20, 2009.

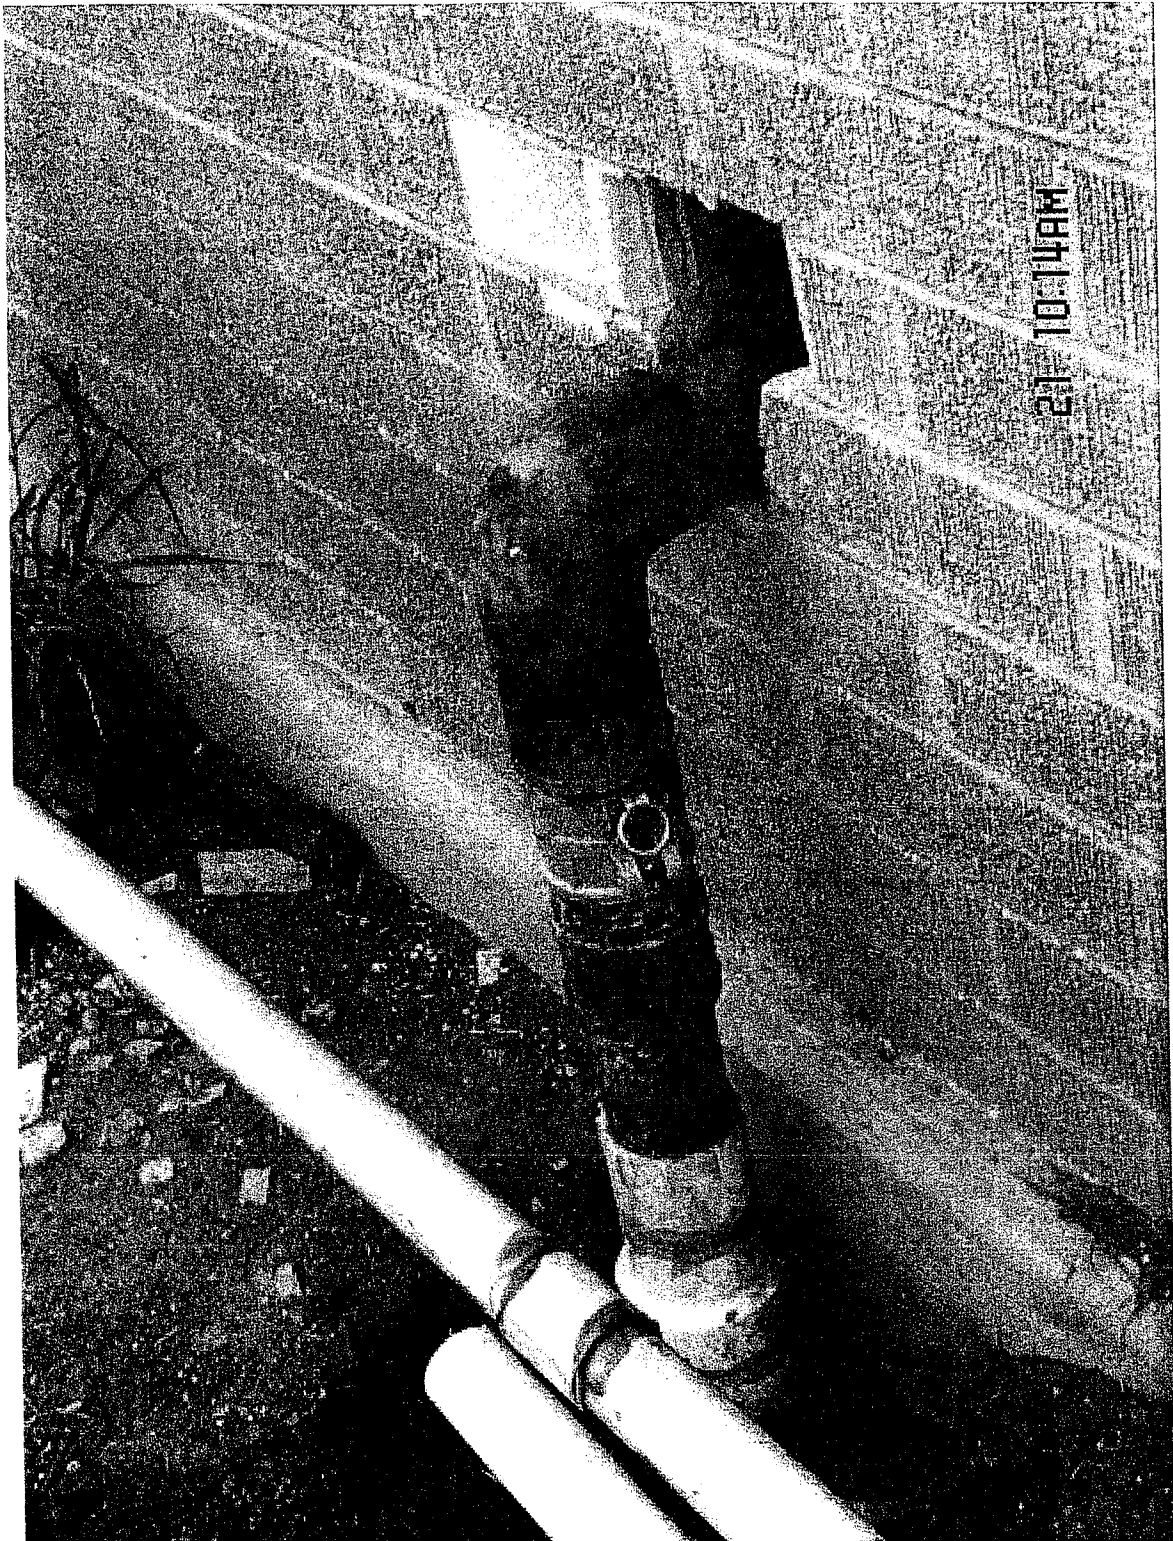
17. This is a picture of the new connection to pump room at MCC Recycling east plant. Note the date in the corner is incorrect. The correct date is August 20, 2009.

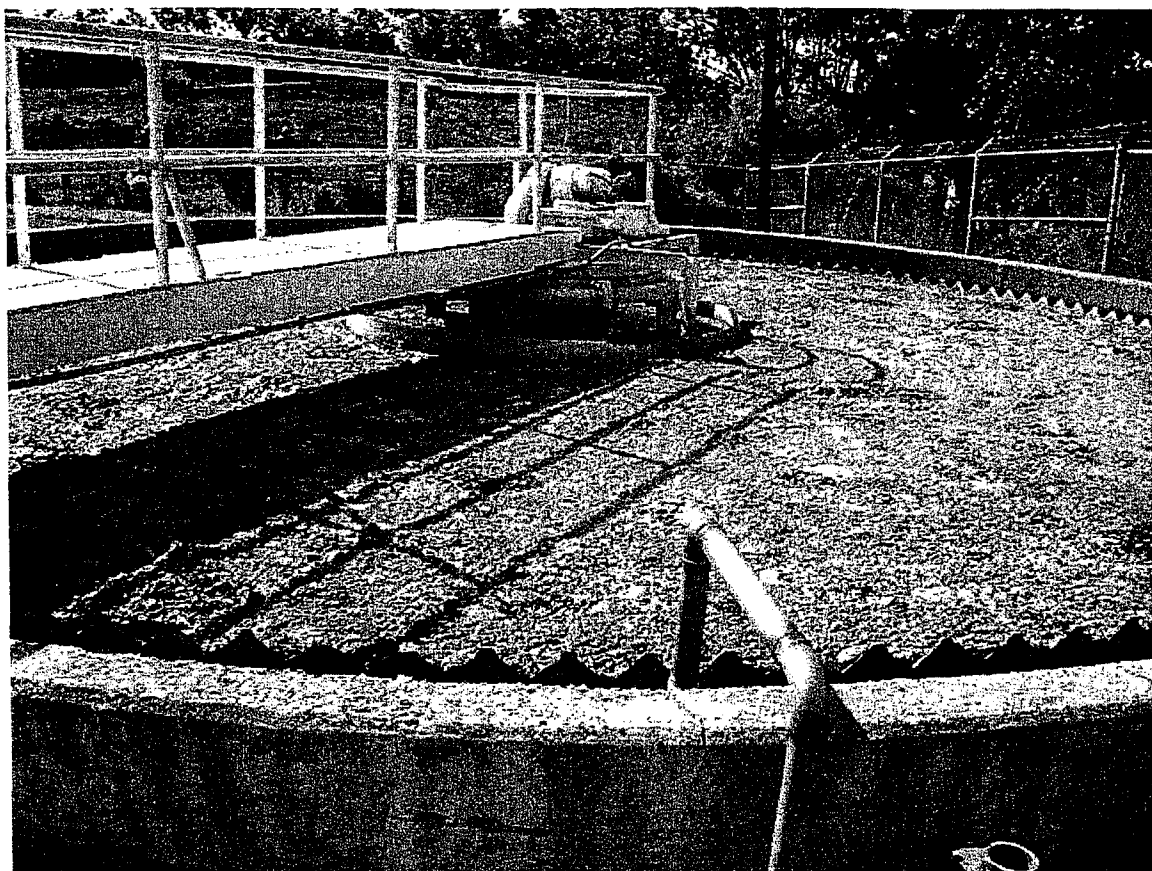
18. This is a picture of final clarifier which receives wastewater from the aeration basin. (The other final clarifiers are used for storage.) The clarifier is located at the MCC Recycling facility east plant near the foot bridge and the pump room. Note the sludge floating on top of the clarifier. The date in the corner of the picture is incorrect. The actual date was August 20, 2009.
